# (4) Application No's: PAP/2010/0462

Beech House, 19 Market Street, Atherstone

Planning Application and Listed Building Consent for conversion of property into three dwellings including associated rear extension and access to rear garden, formation of parking and garden areas.

Beech House, Atherstone: an historic building analysis

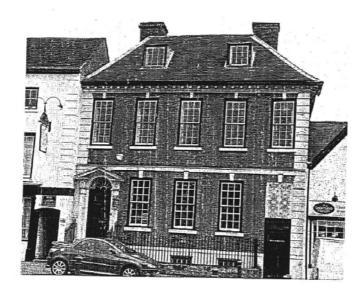
### Plate 1. The front elevation of Beech House.

Beech House has the most handsome elevation of all the buildings facing onto the Market Square (Figure 1). The façade is of pinkish / pale brown bricks laid in Flemish bond; it is of five bays with a service basement plus two full storeys and an attic. Stone dressings include banded rustication at the corners and a string course, and the house has bold moulded and modillion eaves. The middle three bays are fronted by a low stone wall capped by iron railings around the light-well for the basement windows; access for maintenance was by way of a small gate through the curved south end of the fence. The basement is of stone, now stuccoed, with a moulded top, and it is pierced by three windows, now having wooden frames with  $4 \times 4$  panes, but originally they were somewhat smaller, and of stone, lighting what were originally the kitchen and the meat store (see p. 00 below).

On the raised ground floor the main doorway is in the left-hand bay; there are three 9 over 9 sash windows in the central bays, and there is an entry doorway to the right. The main doorway is approached up five stone steps, flanked by iron railings. On each side of the door there is a 1/4-round column standing on a shallow plinth and having a double torus base; an extended neck above the astragal supports a thin abacus decorated by a patera – a form developed from the Tuscan classical order.<sup>2</sup> The semi-circular over-door fanlight has six spokes and seven festoons. All of this is capped by a broken pediment with panelled soffits.3 The heavy door is of six panels; those above the locking rail have beaded edges and elegant fielded panels but the bottom pair are flush, and therefore plausibly of Nicholas Smith's time, or to that of Sarah and William Hanson. The door retains a good metal knocker (late Georgian / Victorian?), an Edwardian letterbox and three key-holes.

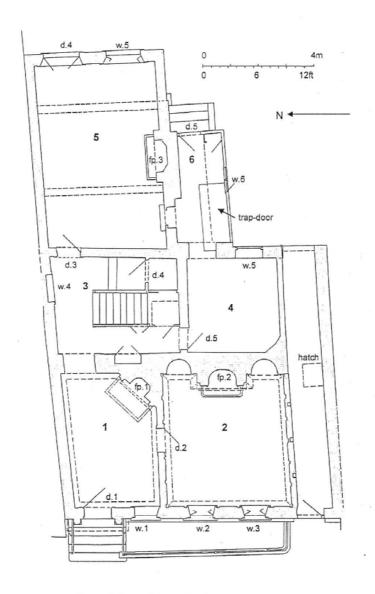
Figure 1. Ground-floor plan of Beech House.

The ground floor (Figure 2) now comprises a large entrance lobby (1), a panelled reception room (2), an inner staircase lobby (3) and what is at present a kitchen (4), replacing the older one in the basement. During the early 19th century another room beyond the staircase lobby (5) was extended to the east. A lean-to structure (6) was added to the side of the back range over what began as external steps down to the basement.

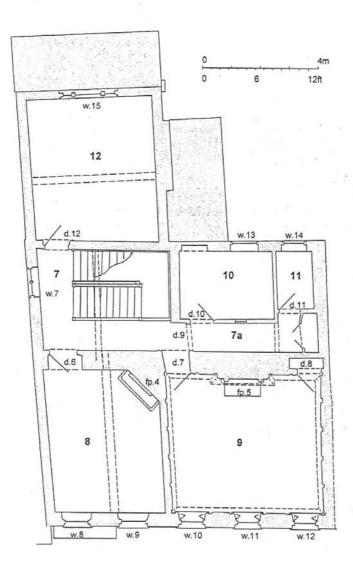
Figure 2. First-floor plan of Beech House.

The stair and distribution lobby (7) lead to two rooms (8 and 9) overlooking the market place at the front of the house; the largest of these may have been designed as a 'salon' for entertaining guests. A bathroom and a lavatory now occupy the SE corner on this floor. At this level room 12 in the back range has retained its original proportions.

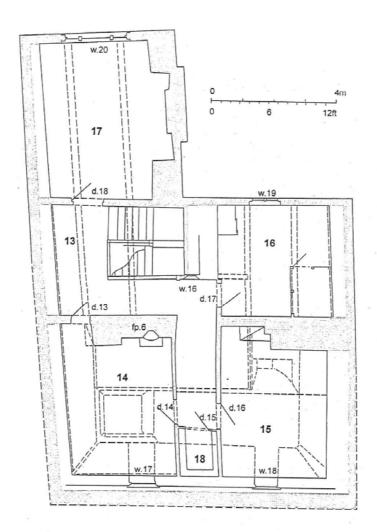
Figure 3. Second floor (attic) plan of Beech House.

Four rooms (14-17), all partly within the roof-space, are served by the distribution lobby 13.

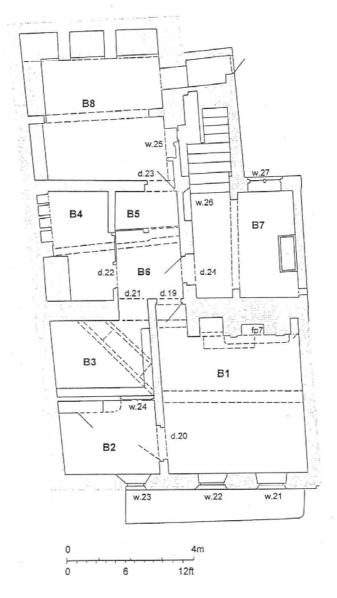
Figure 4. The basement of Beech House.

The kitchen was accessed by way of doorway d.19. The sturdy 4-panel door has glazing in the top two panels to provide borrowed light to the lobby, and it is fitted with a lock-box with metal doorknobs. Inside the kitchen, there is a shelf over the door. Square ceramic tiles on the floor. The lath and plaster ceiling is in a poor condition and subject to (dry?) rot. One small portion of panelling remains to show that the horizontal line round the walls indicates the top of the beaded boards that once lined to walls to a height of about 1m. Otherwise the walls are lime-plastered (damp and in poor condition).

The kitchen is lit by two windows (w.21 and w.22) in the front wall, and these are likely to be at least the third generation. Each has a wooden frame with a central mullion and the two fixed lights have 2×4 panes. These window frames are relatively recent (softwood?) replacements of older (second generation) wooden windows that had been inserted to improve the level of daylight. As can be observed within the brick reveals, the original basement windows were shallower, and therefore smaller; they were of sandstone, and they were probably divided into two lights by a single mullion. The remnants of one such window (w.25) may survive in BS (see below). There are two metal hooks over each window. A beam set into the thickness of the wall and extending across the top of these two windows retains eight empty pegged

The grate and the oven were on the wall opposite the windows. The fireplace (fp7) is in mid - late 19th-century style, with a segmental brick arch under a bracketed mantel shelf. However, the original grate has been removed. The alcove to the left of the fireplace is served by a flue, and presumably it originally housed a baking oven. Tucked into the corner at the side of the fireplace is a narrow cupboard with a side-hung door and four very long compartments; these are much deeper than spice cupboards and they are provisionally interpreted here as an alternative to a spit rack.
