PAP/2023/0071

## Great Crested Newt Survey and Watercourse Assessment

Land at Nailcote Farm, Fillongley, Coventry, North Warwickshire, CV7 8DW

Enviromena Project Management Ltd

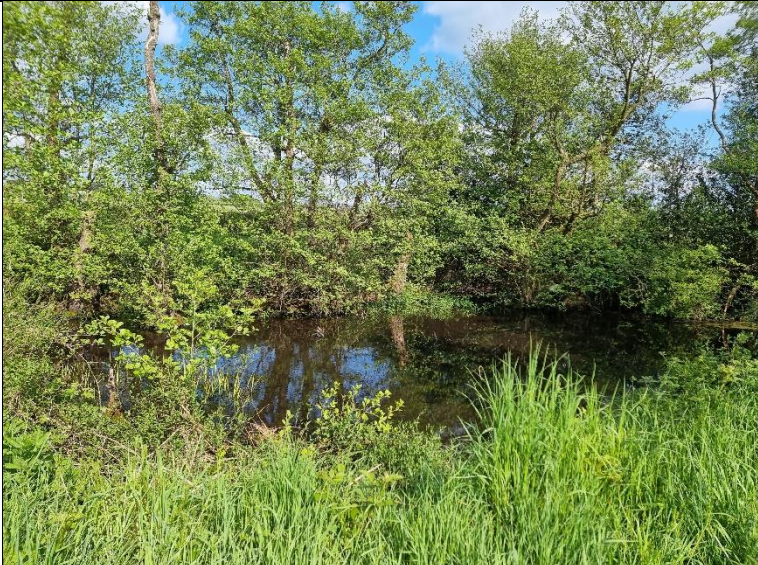
Ref	Description	Photograph
Pond 3	Pond three is located approximately 100m from the site boundary at SP28148614. It is surrounded by tall neutral grassland, with a border of trees and shrubs around the perimeter of the pond. The pond contained a large amount of water and based on the muddy embankments, it is evident that cattle and dogs enter this pond frequently with a loss of vegetation around the edges. In addition, there was a low level of submergent vegetation within the pond, being concentrated on the south-western embankment and the middle of the waterbody. Willows, oaks, hawthorn, and blackthorn line the edge of the pond creating some level of shade and resulting in a layer of leaf litter within the pond. No amphibians were observed during the survey of the pond.

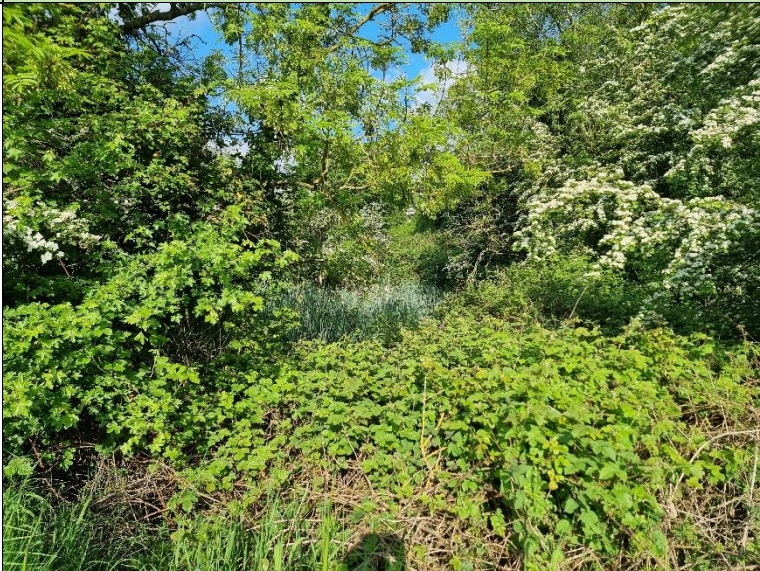
Ref	Description	Photograph
Pond 2	<p>Pond 2, south of Pond 1, located at SP28128573, is inaccessible. There is a dense encroachment of bramble, nettles and hedgerow species around the perimeter which prevents access to the water and pond. The brambles were approximately 1.5m tall and 2m wide.</p> <p>From looking over the top of the bramble, it is apparent that the pond is filled with bulrush and rushes and looks to be densely packed with vegetation.</p>

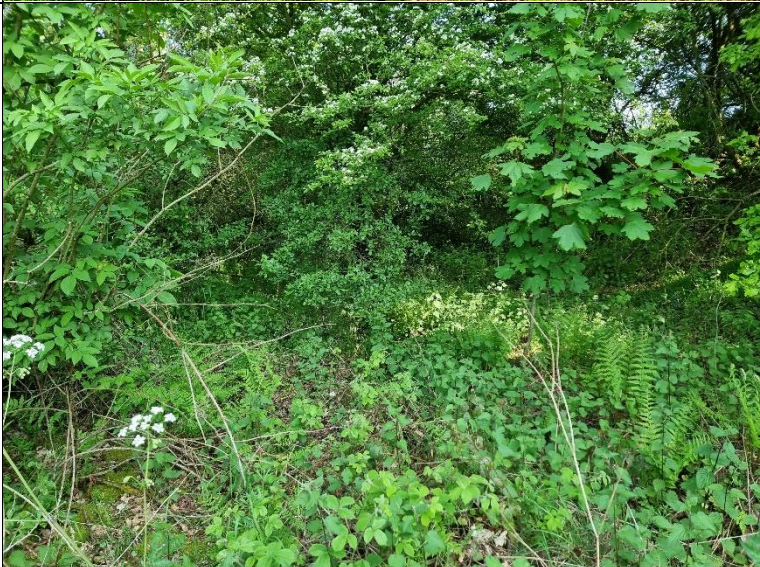
Pond 1	<p>Pond 1 could not be observed in any way unlike Ponds 2 and 3. There was no access to the perimeter due to wire fencing and dense scrub.</p>

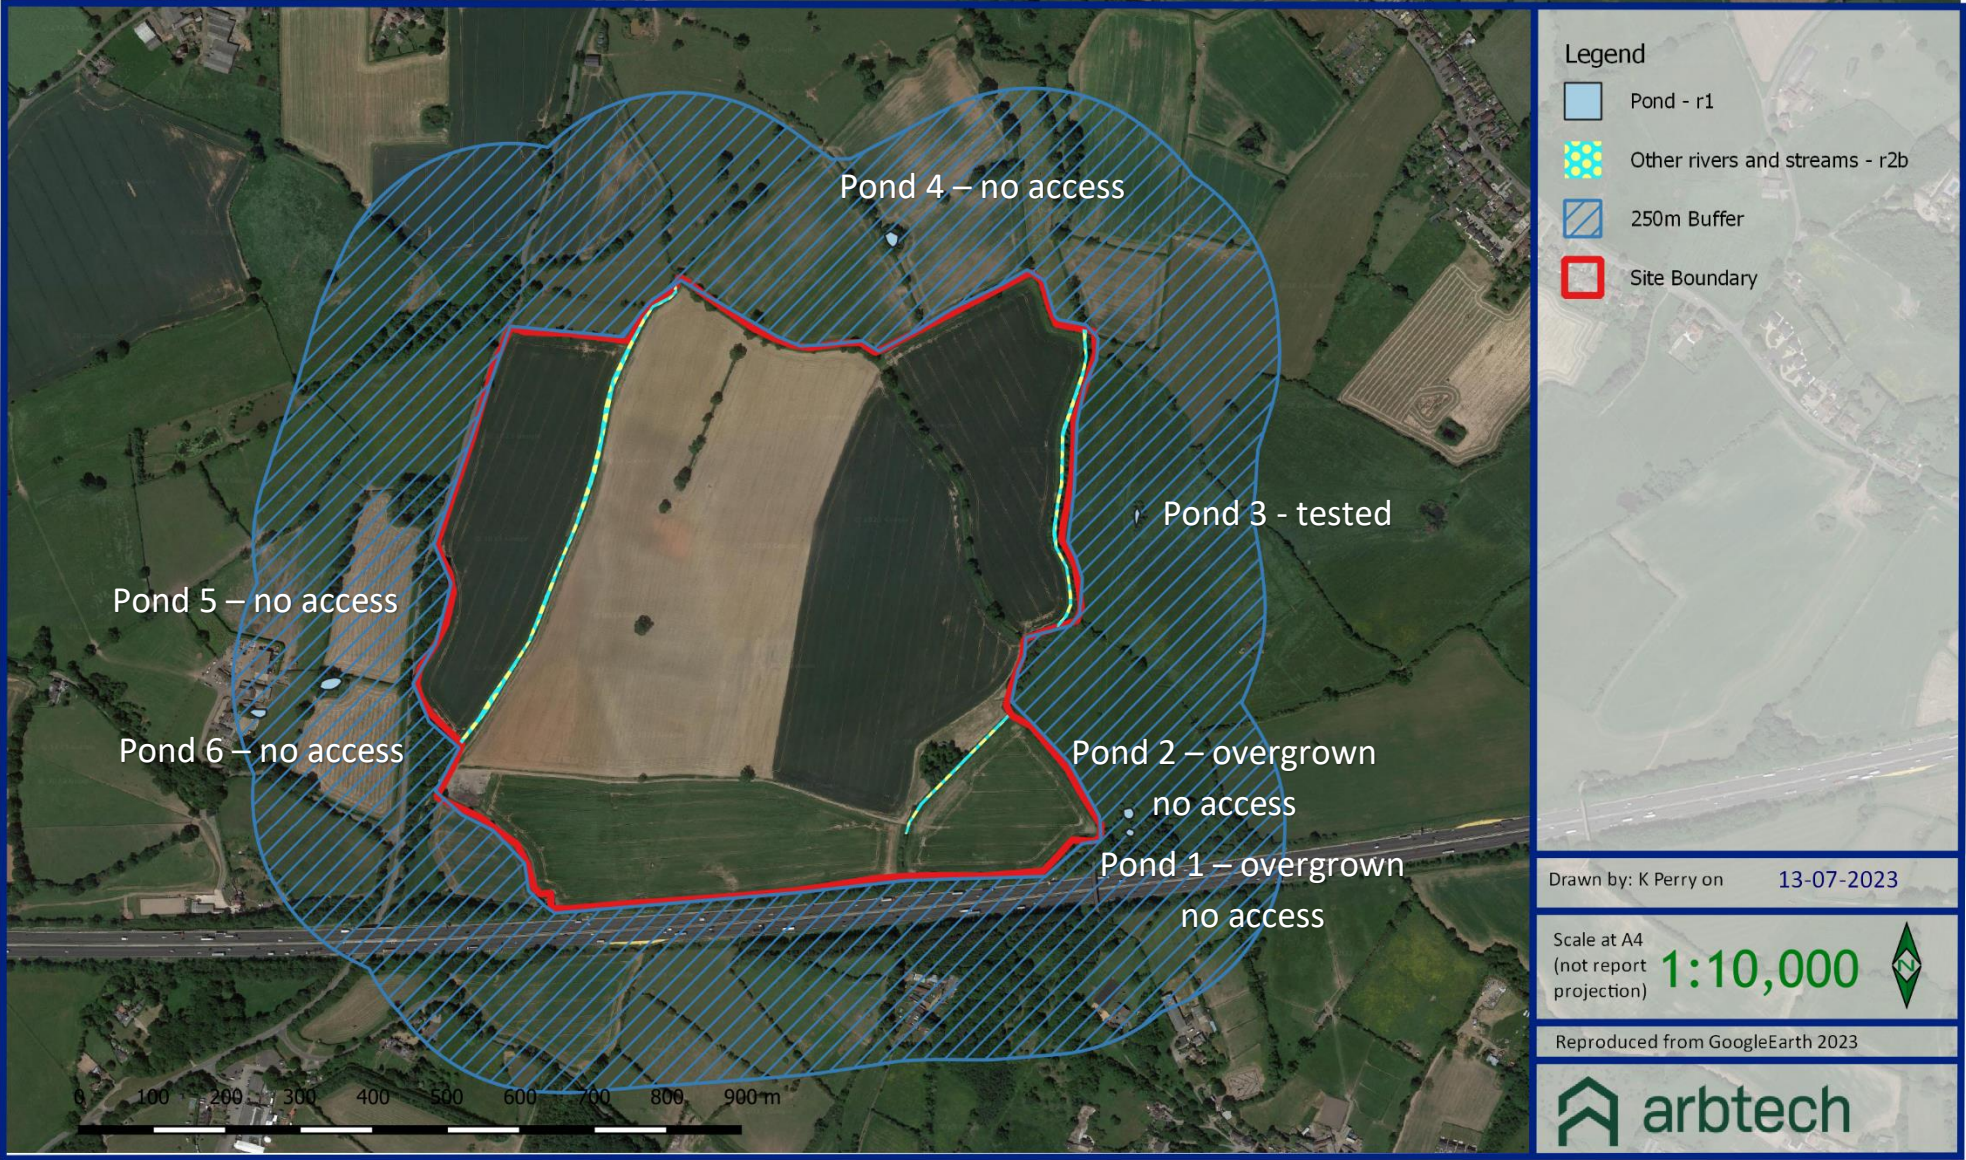
Appendix 3: GCN Survey Plan

A plan showing the survey results is provided in Appendix 3. The weather conditions recorded at the time of the survey are shown in Table 2. Pond and watercourse descriptions are provided in Table 3, HSI assessment in Table 4 and eDNA results in Table 5. The SureScreen lab results are included in Appendix 4.
