# VERIFICATION REQUIREMENTS FOR GAS PROTECTION SYSTEMS

Technical Guidance for  
Developers,  
Landowners and  
Consultants

Yorkshire and Lincolnshire  
Pollution Advisory Group

Version 1.1 – December 2016

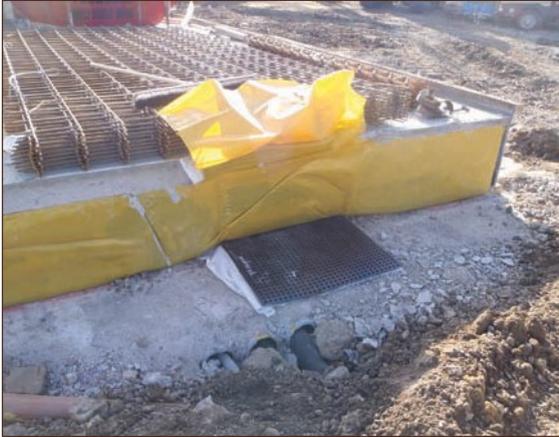
**Figure A4.7** Geovent protruding out of the frontage of the unit. Gas membrane along the sides of the slab preventing lateral gas ingress (courtesy Alderburgh Group)

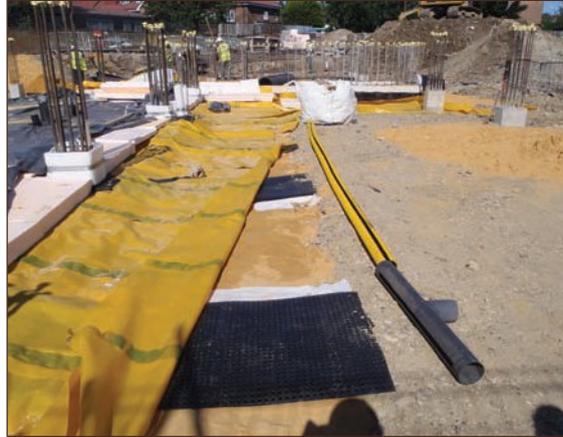
**Figure A4.8** Geovent beneath the 2000g taped gas membrane lined up with collector pipes (courtesy Alderburgh Group)

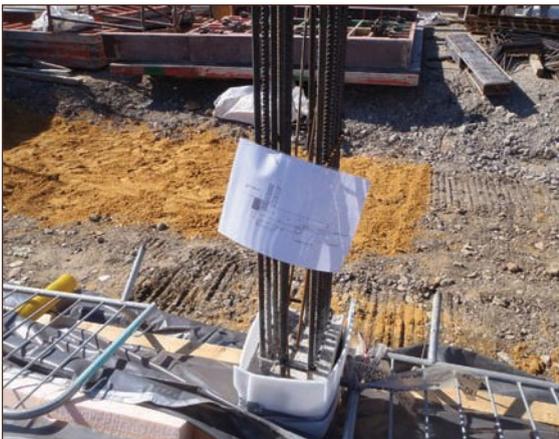
**Figure A4.9** On site schematics to aid construction workers build the gas protection system (courtesy Alderburgh Group)

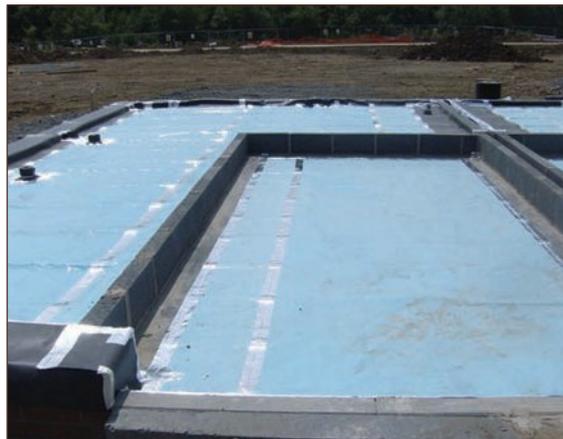
**Figure A4.10** Almost complete coverage available for inspection, minimal jointing, service entries suitable distance from walls, light traffic (courtesy Smith Grant)

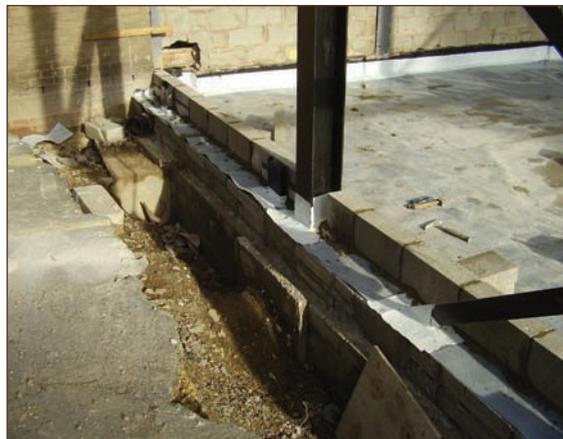
**Figure A4.12** Good edge detail across cavity (courtesy PAGEotechnical Ltd)

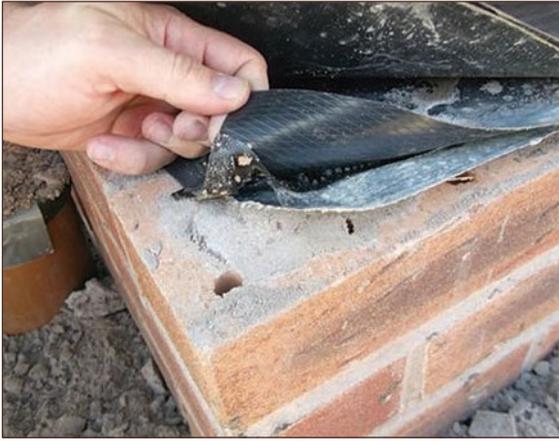
**Figure A4.13** Gas proof DPC adhered on top of gas membrane using butyl strips across cavity space (courtesy NHBC)

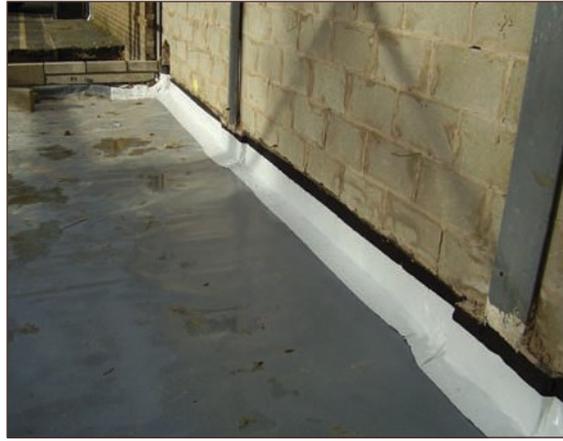
**Figure A4.14** Good perimeter seal (courtesy PAGEotechnical Ltd)

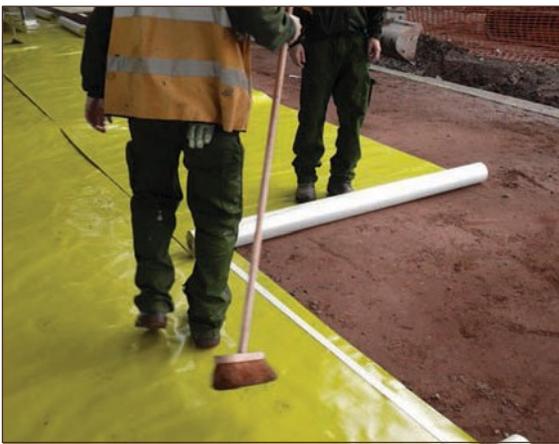
**Figure A4.15** LDPE type gas membrane overlap and double sided tape. Sand blinding to protect underside of gas membrane (courtesy A Proctor Group)

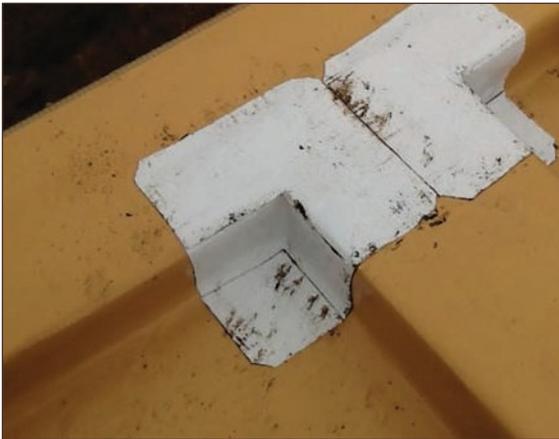
**Figure A4.21** Good prefabricated corner detail (courtesy MEC Environmental Ltd)

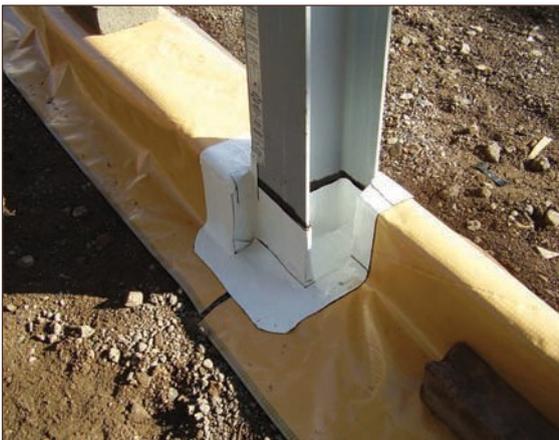
**Figure A4.23** Complex column seal (courtesy PAgotechnical Ltd)

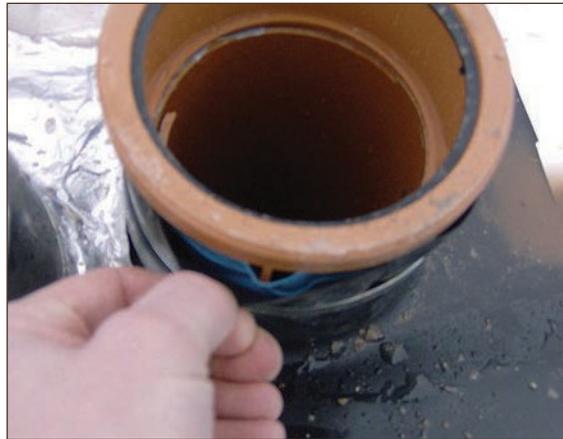
Figure A4.28 Bead of double sided butyl tape provided between interfaces of ID top hat and OD service pipe. When compressed with jubilee clip, forms an effective seal (courtesy Smith Grant)

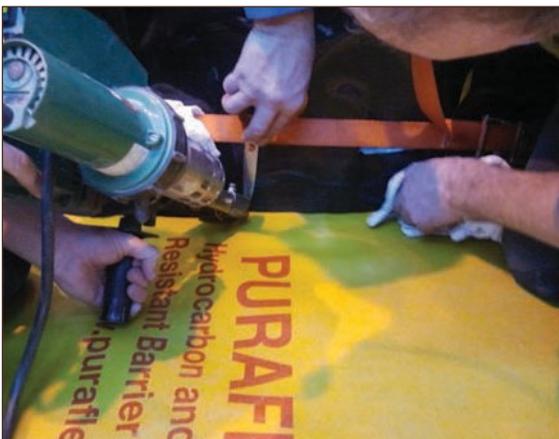
Figure A4.29 Extrusion welding technique (courtesy Industrial Textiles & Plastics Ltd)

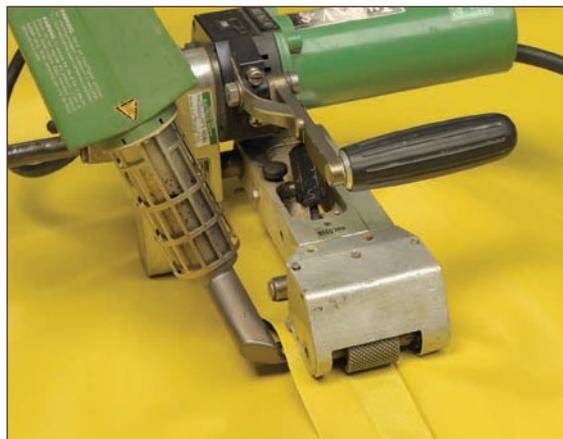
Figure A4.30 Thermal welding technique (courtesy Industrial Textiles & Plastics Ltd)

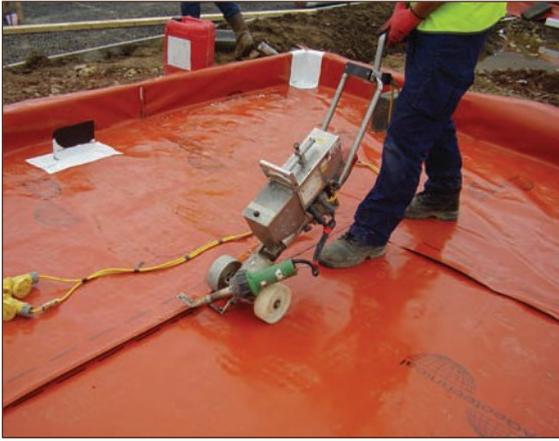
**Figure A4.31** *Extrusion welding (courtesy PAGeotechnical Ltd)*

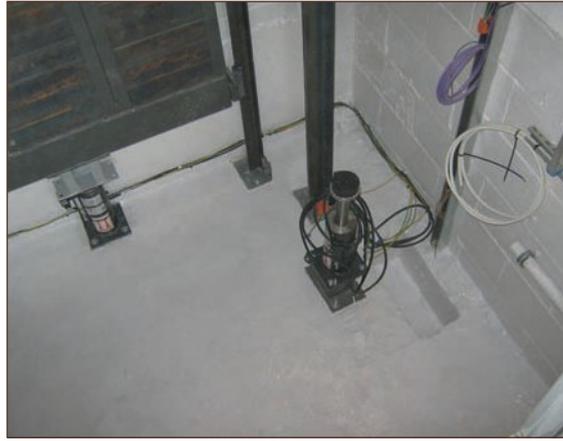
**Figure A4.32** *High quality installation of liquid gas membrane to lift pits, including resin gas protection on all screw penetrations (courtesy Card Geotechnics Limited)*

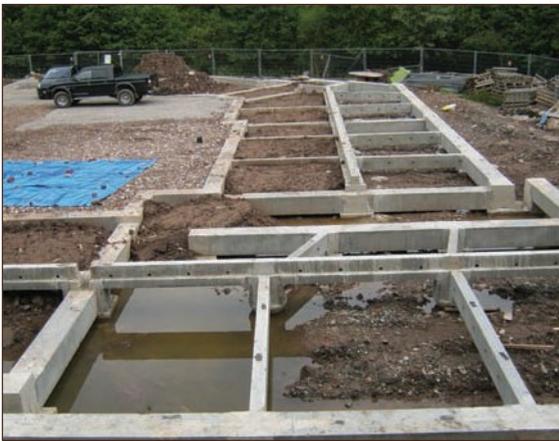
**Figure A4.33** *Good ventilation in internal sleeper walls, cast into prefabricated beams (courtesy Smith Grant)*

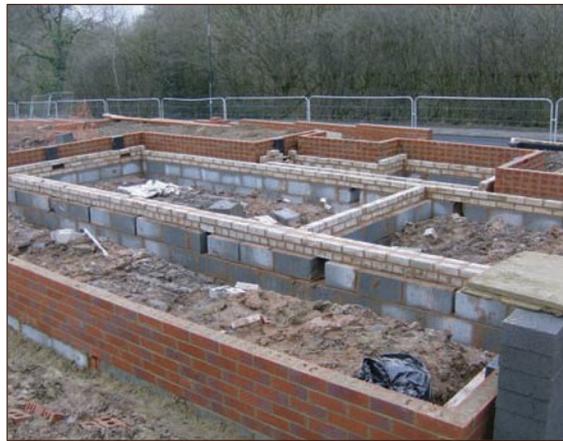
**Figure A4.34** *Open void >300mm deep, good ventilation through internal sleeper walls (courtesy Smith Grant)*

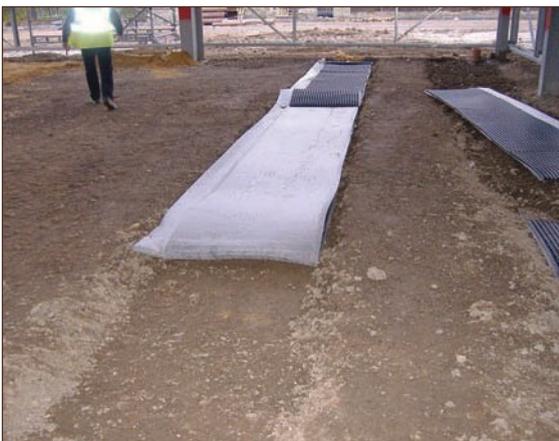
**Figure A4.35** *Good installation of passive gas venting trenches and 'egg-crate' (courtesy Card Geotechnics Limited)*

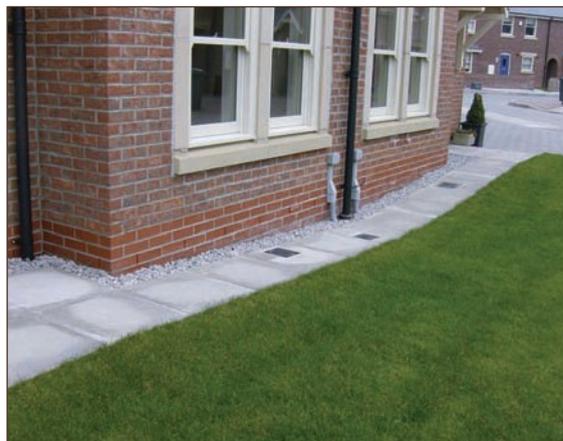
**Figure A4.36** *Raised air bricks are preferable due to the reduced potential for blockade but the vent trench specified is provided with clean single sized stone (courtesy Smith Grant)*

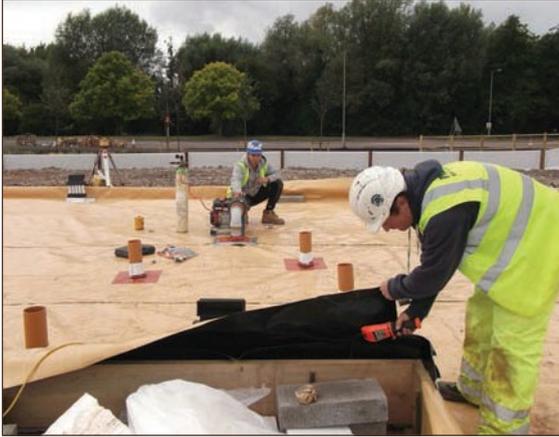
Figure A4.37 Tracer gas testing, whereby gas or smoke is applied under pressure beneath the installed gas membrane and detectors are used to screen for leaks above (courtesy NHBC)

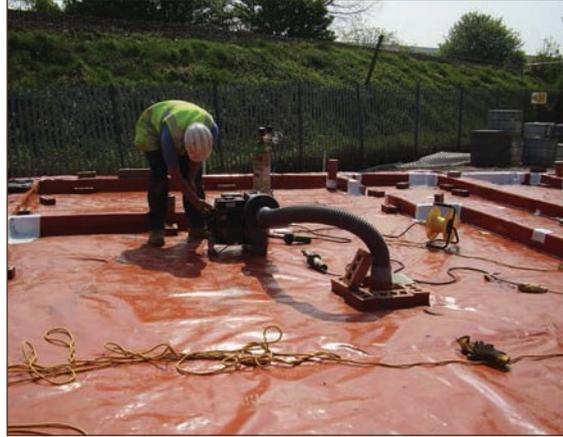
Figure A4.38 Tracer gas testing (courtesy PAGeotechnical Ltd)

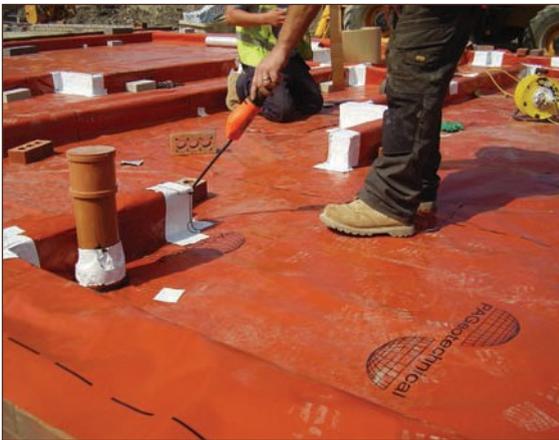
Figure A4.39 Scanning for leaks (courtesy PAGeotechnical Ltd)

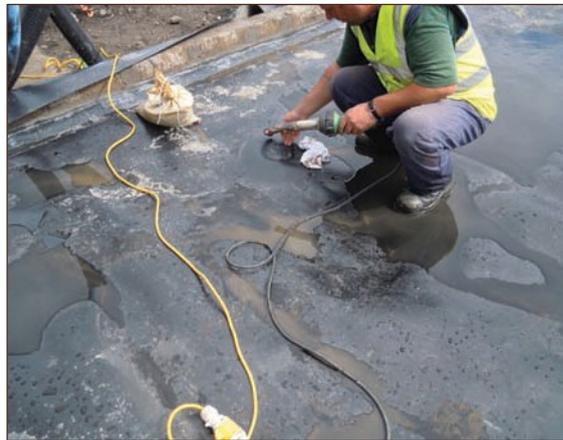
Figure A4.40 CO<sub>2</sub> injection integrity testing (courtesy Landline Ltd)

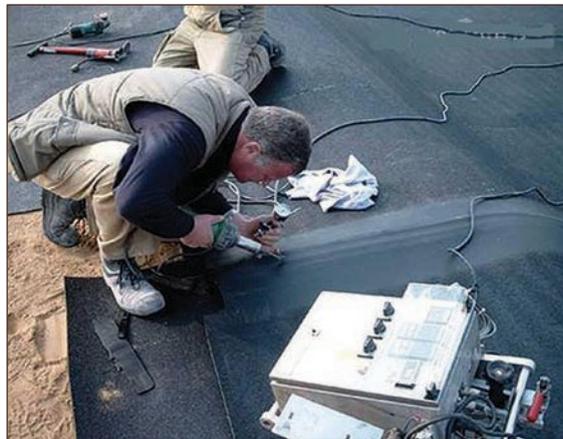
Figure A4.42 Air pressure testing (courtesy GSE Environmental)

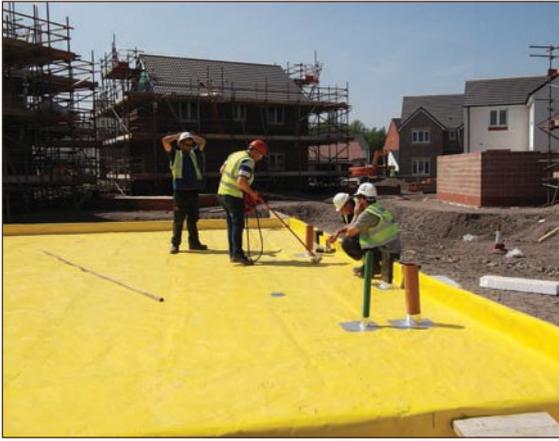
Figure A4.43 Dielectric porosity testing for housing scheme (courtesy NHBC)

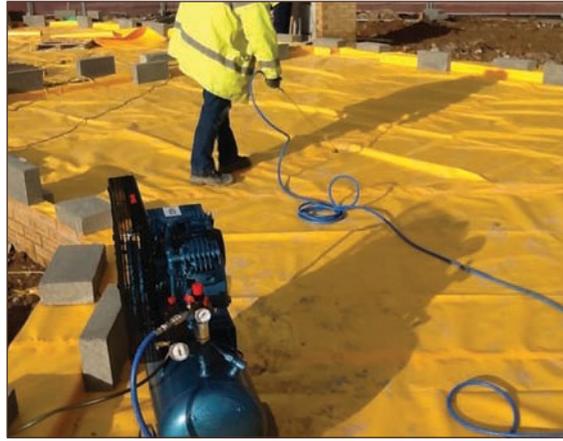
Figure A4.44 Air lance test, used to test the quality of welded seams along gas membrane joints (courtesy MEC Environmental Ltd)

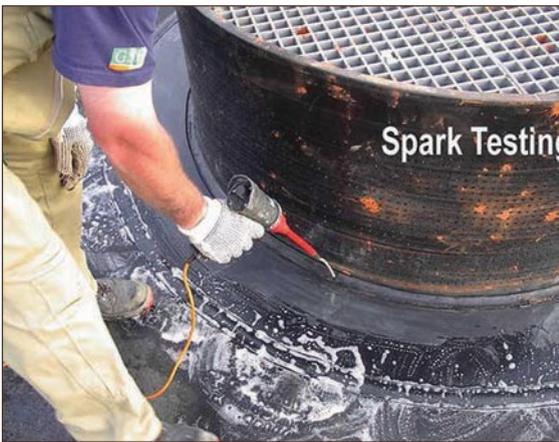
Figure A4.45 Spark testing (courtesy GSE Environmental)

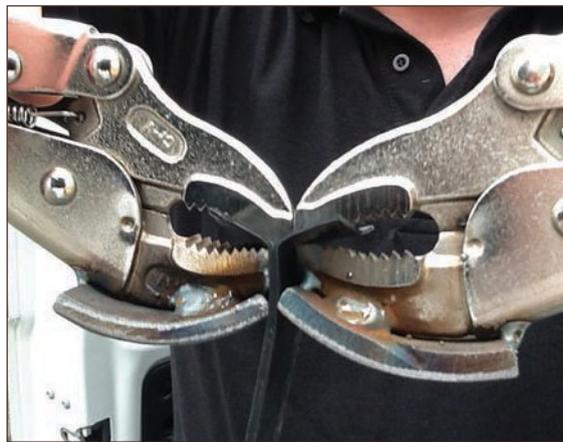
Figure A4.46 Testing a weld with 'dog bone' grips (courtesy MEC Environmental Ltd)

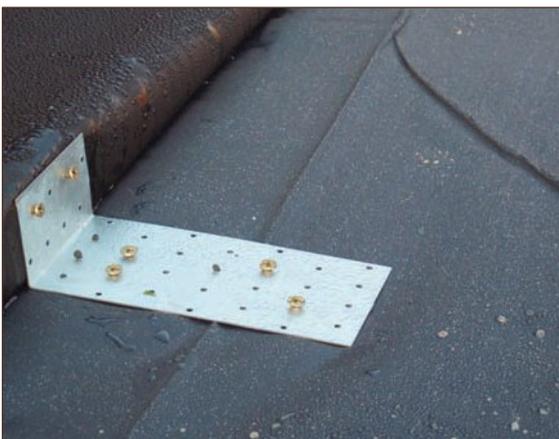
Figure A4.47 Follow-on works purposefully penetrating gas membrane (courtesy Card Geotechnics Limited)

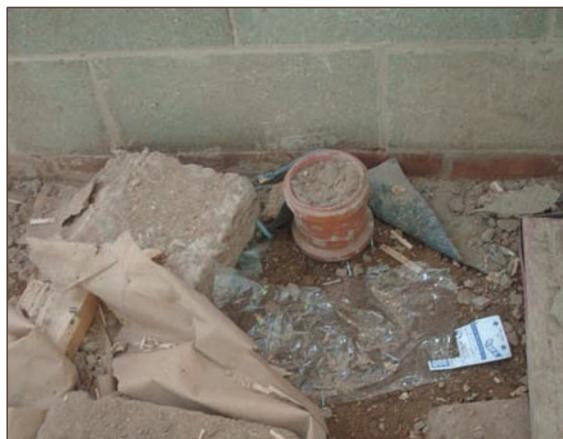
Figure A4.48 Loose nails and over construction debris likely to be left in place beneath gas membrane – poor preparation of gas membrane prior to sealing service penetration (courtesy Card Geotechnics Limited)

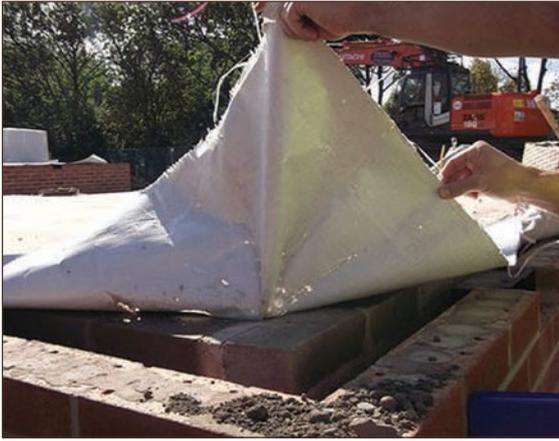
**Figure A4.49** *Lifted gas membrane at corner position. Light penetrating through confirms damage to aluminium internal core layer (courtesy NHBC)*

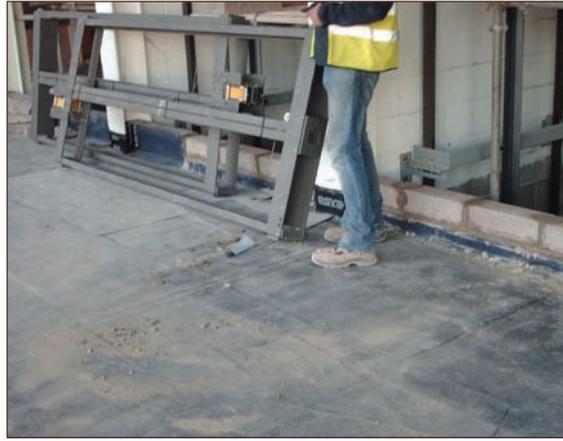
**Figure A4.50** *Large/heavy/sharp objects being moved over unprotected gas membrane (courtesy Card Geotechnics Limited)*

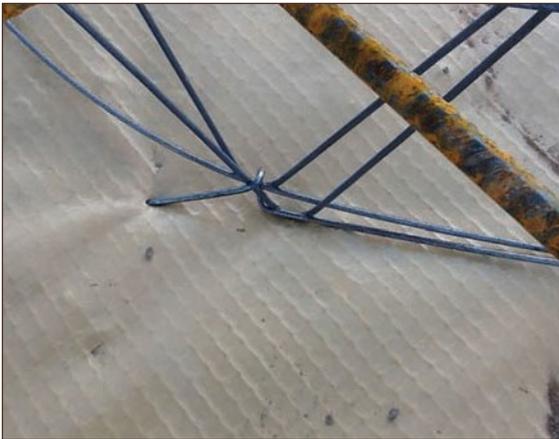
**Figure A4.51** *Gas membrane torn by reinforcement (courtesy MEC Environmental Ltd)*

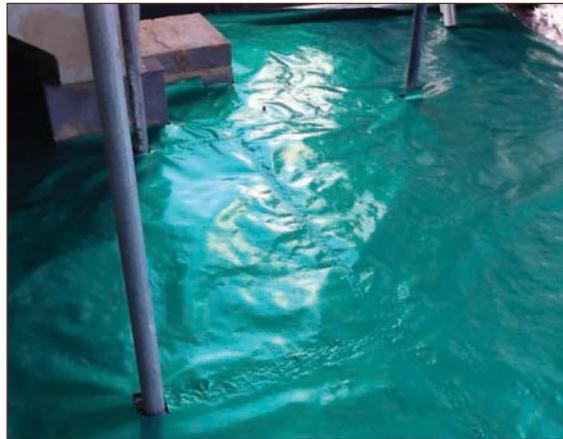
**Figure A4.52** *Gas membrane cut by scaffolders and bricklayers after installation (courtesy MEC Environmental Ltd)*

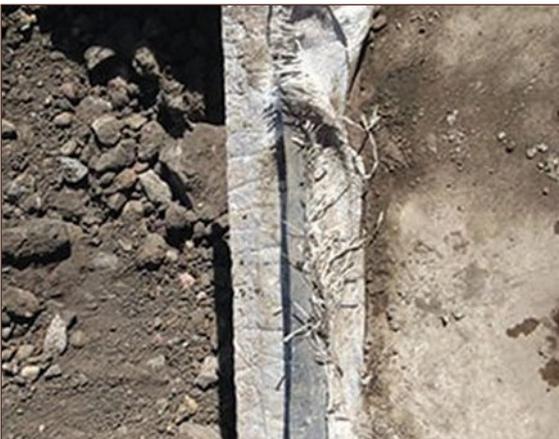
**Figure A4.53** *Gas membrane left exposed for long period of time, shows significant fraying at cavity edge (courtesy NHBC)*

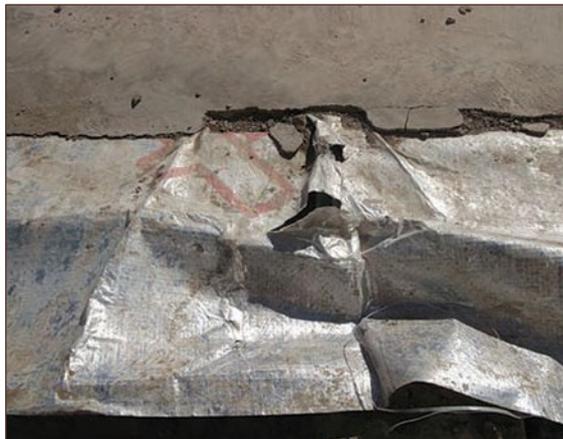
**Figure A4.54** *Gas membrane damage/tearing at edge of ground floor slab screed layer where it was left exposed to elements for period of time (courtesy NHBC)*

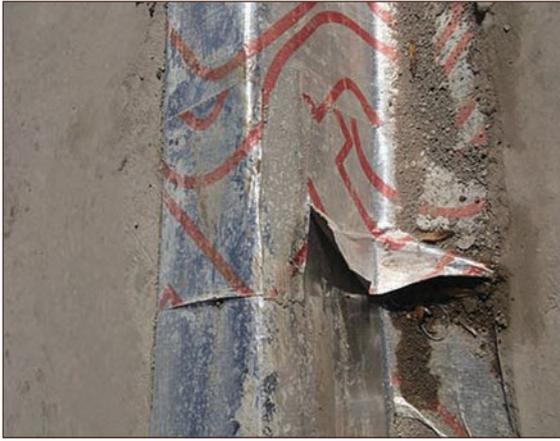
**Figure A4.55** Gas membrane at stepped junction of slab to integral garage, appears to be susceptible to tearing when screed is poured. Screed may also weigh down on gas membrane if fitted too tight (courtesy NHBC)

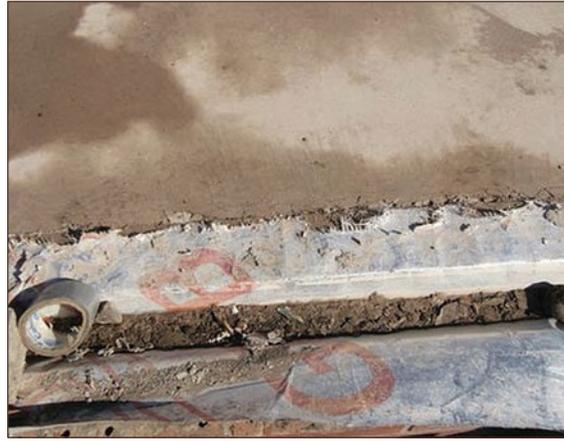
**Figure A4.56** Gas membrane at edge of concrete screed. Screed has been grinded to achieve desired levels, gas membrane shows extreme wear and damage as a result (courtesy NHBC)

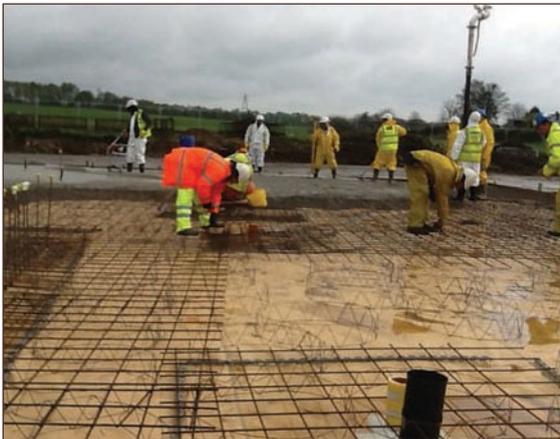
**Figure A4.57** Unprotected gas membrane damaged by heavy traffic (courtesy MEC Environmental Ltd)

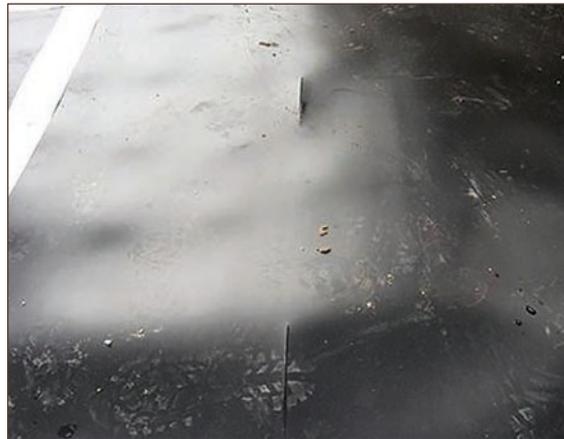
**Figure A4.58** Damage caused to gas membrane by follow-on trade who cut/shaped the dry lining board directly on the unprotected installed gas membrane (courtesy NHBC)

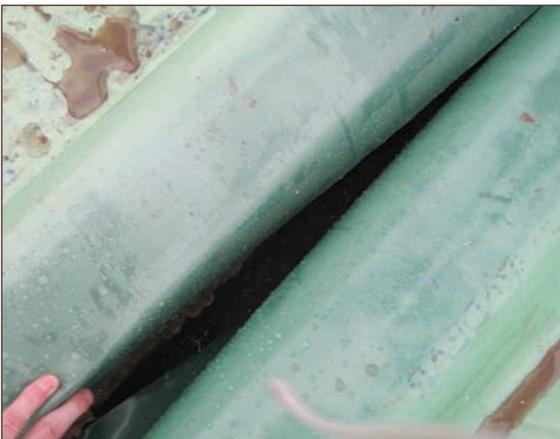
**Figure A4.59** Gas membrane slit at the bottom of a cavity tray to enable water to drain away (courtesy Smith Grant)

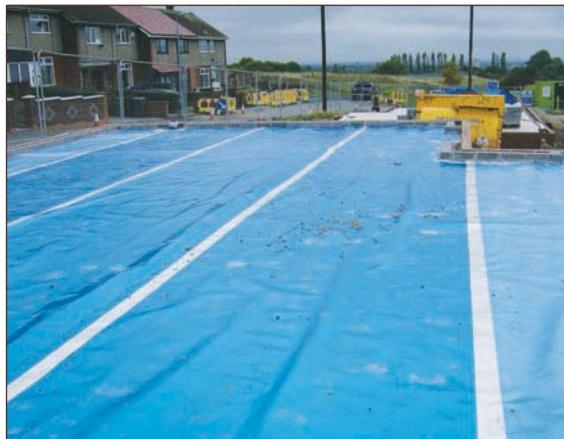
**Figure A4.60** Some stones could penetrate gas membrane if sufficient force is applied (courtesy Smith Grant)

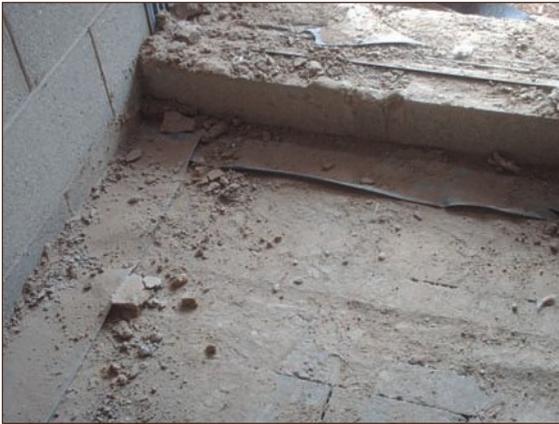
**Figure A4.63** Absence of surface preparation prior to laying of gas membrane, debris likely to pierce gas membrane (courtesy Card Geotechnics Limited)

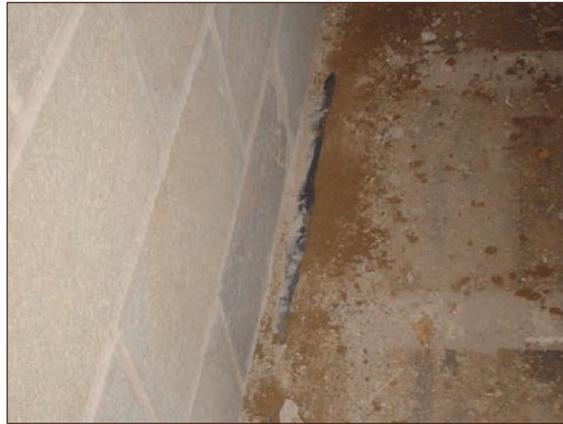
**Figure A4.64** Insufficient length of gas membrane protruding through wall to overlap with gas membrane within building (courtesy Card Geotechnics Limited)

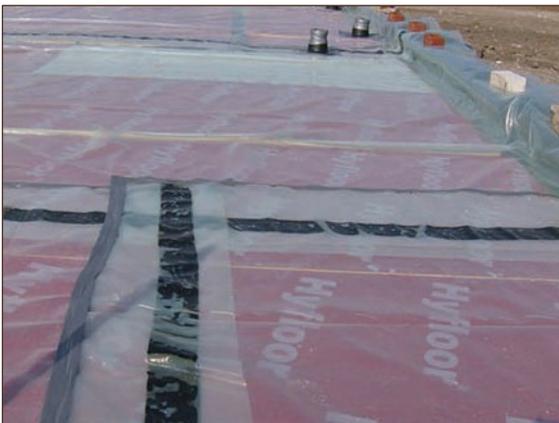
**Figure A4.65** Wrinkling of gas membrane over joint has resulted in gaps (only visible due to the use of a transparent gas membrane) and the secondary seal uses ordinary gaffer tape rather than a proprietary product (courtesy Smith Grant)

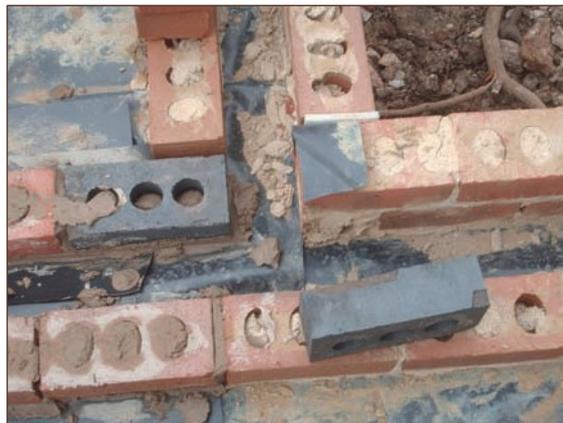
**Figure A4.66** Follow-on trades proceeded work before gas membrane joints sealed (courtesy Card Geotechnics Limited)

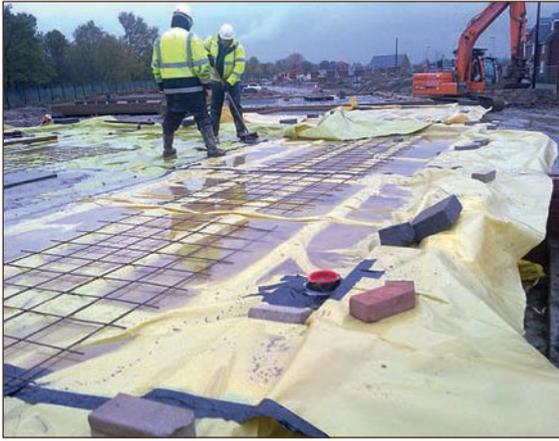
**Figure A4.67** Traffic over mesh resulted in several punctures, in addition most joints were found to be poorly constructed. Taped joints are difficult to construct in adverse weather (courtesy Smith Grant)

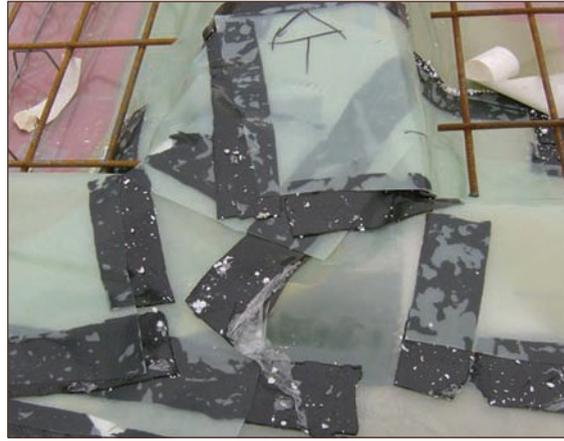
**Figure A4.68** A pre-formed corner unit would have been preferable. The installer could not produce sufficient quality despite the amount of tape applied (courtesy Smith Grant)

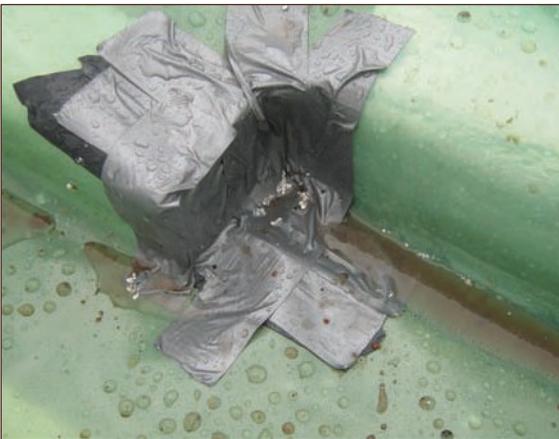
**Figure A4.69** Attempt at corner detailing using non-proprietary duct tape (courtesy Smith Grant)

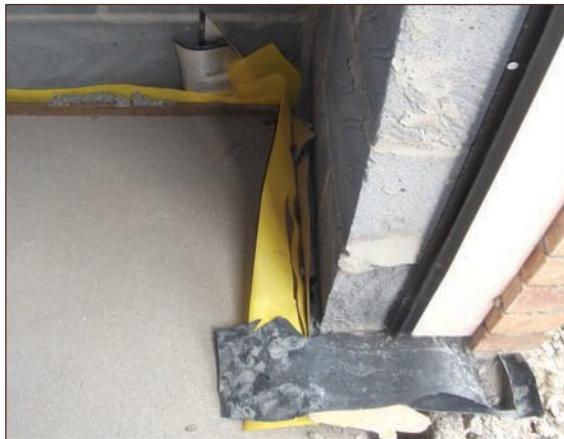
**Figure A4.70** Inadequate corner detailing. The use of preformed proprietary products would have avoided such bad practice (courtesy NHBC)

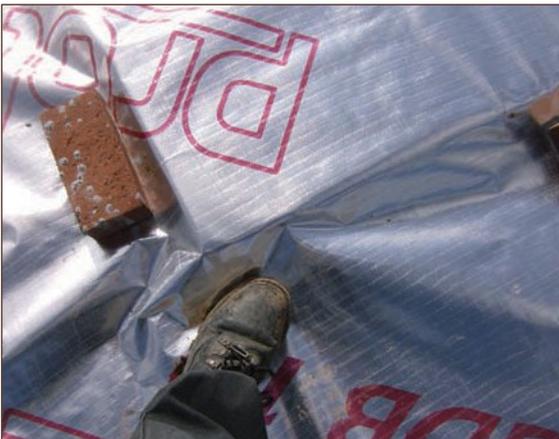
**Figure A4.71** No corner detailing leading to stress point on gas membrane (courtesy Smith Grant)

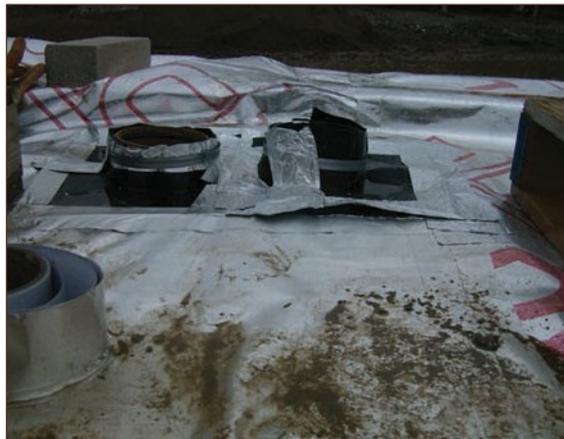
**Figure A4.72** Joint between top hat and gas membrane has lifted due to poor fit and attempt to construct in very wet conditions (courtesy Smith Grant)

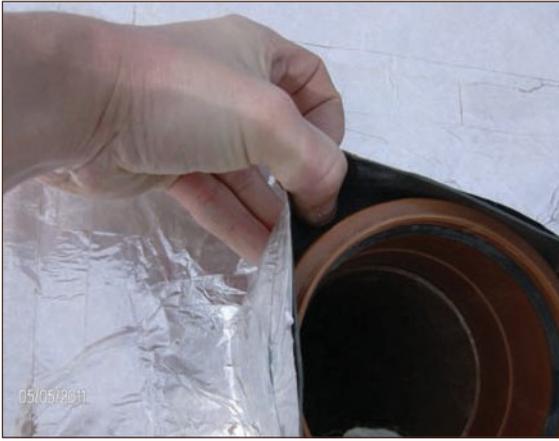
**Figure A4.73** No bead of double sided butyl tape provided between interfaces of ID top hat and OD service pipe: cannot be compressed enough to form seal (courtesy Smith Grant)

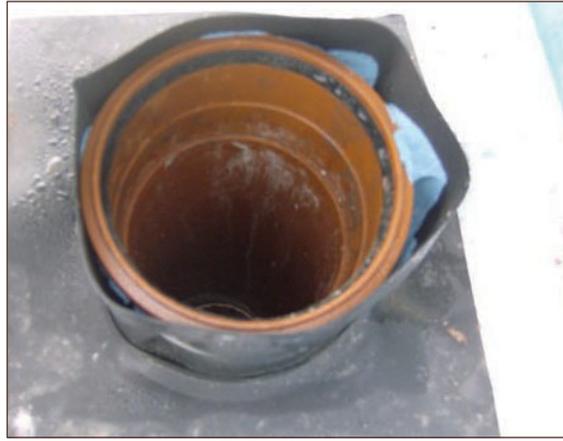
**Figure A4.74** Gap between OD of service pipe and ID of top hat too large: cannot be compressed enough to form seal, even with the application of additional tape (courtesy Smith Grant)

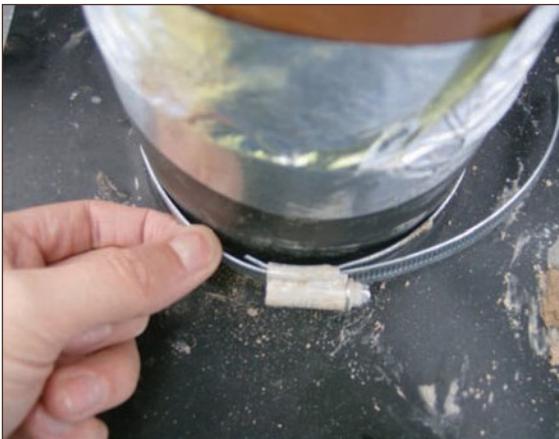
**Figure A4.75** Jubilee clip on service entry insufficiently tightened so joint is uncompressed (courtesy Smith Grant)

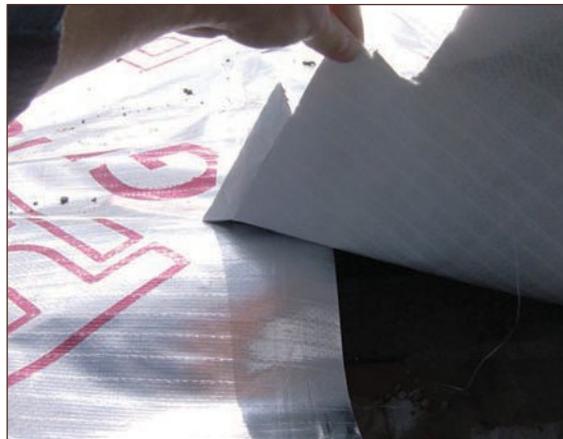
**Figure A4.76** No double sided tape used in joints (courtesy Smith Grant)

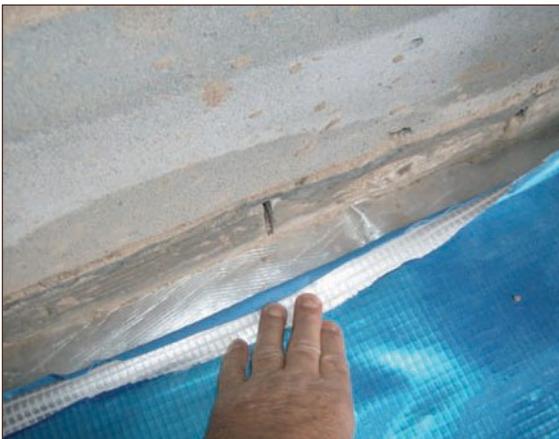
**Figure A4.77** Small lap and no single sided tape used to achieve secondary seal (courtesy Smith Grant)

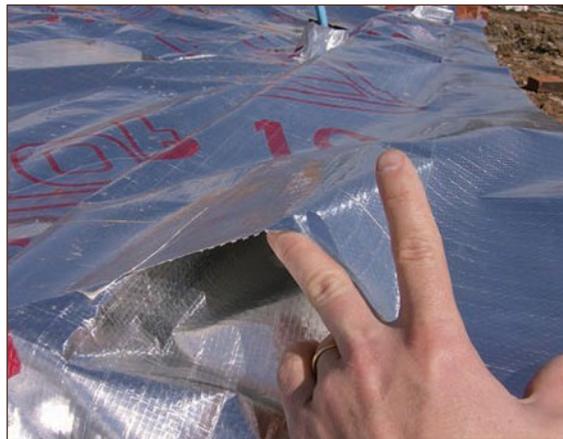
**Figure A4.78** Gap in jointing over wall cavity big enough to insert fist (courtesy Smith Grant)

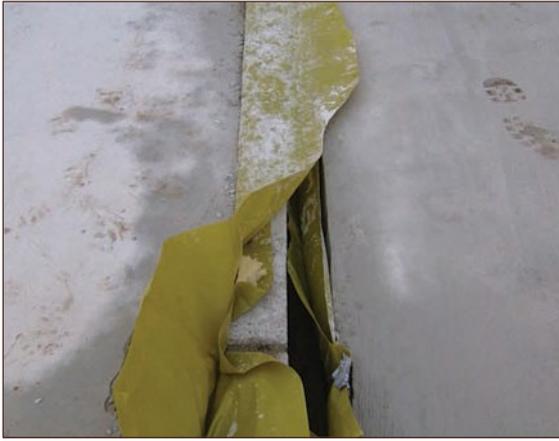
**Figure A4.79** Gas membrane not continuous over internal wall. It had been deliberately cut open for unknown purpose (courtesy Smith Grant)

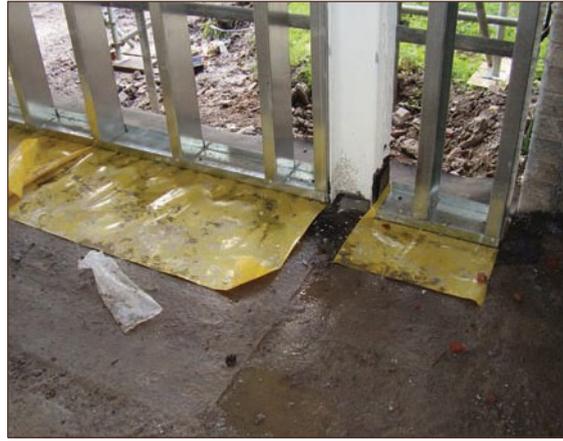
**Figure A4.80** Column left unsealed (courtesy PAGEotechnical Ltd)

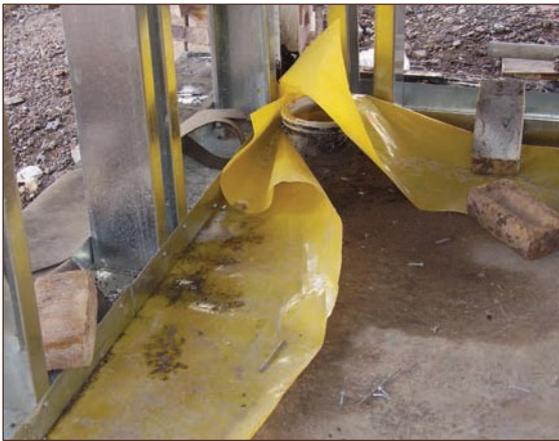
**Figure A4.81** No seal to perimeter pipe (courtesy PAGEotechnical Ltd)

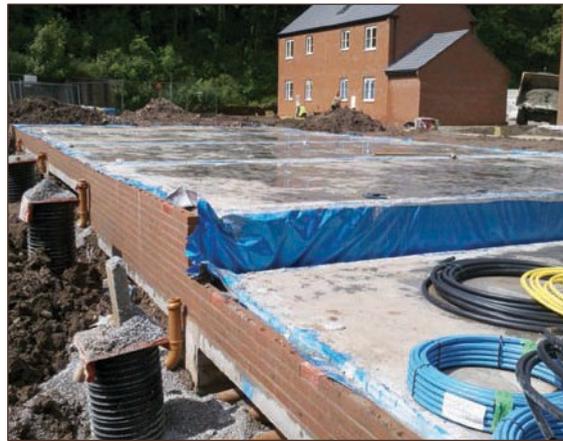
**Figure A4.82** Gas membrane used to bridge cavity wall instead of DPC, leaving it exposed to damage by follow-on trades (courtesy Smith Grant)

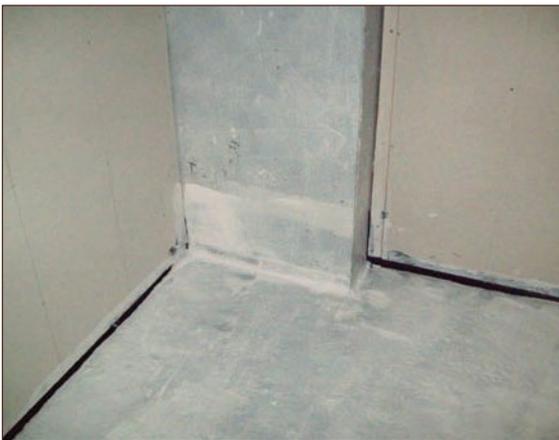
**Figure A4.83** Poor quality installation of liquid gas membrane. Liquid gas membranes come in two colours (black and white) allowing coverage of each coat to be easily assessed. Here the gas membrane has been spread too thinly and inconsistently. In addition, it appears to have been applied to a damp surface, causing blistering (courtesy Card Geotechnics Limited)

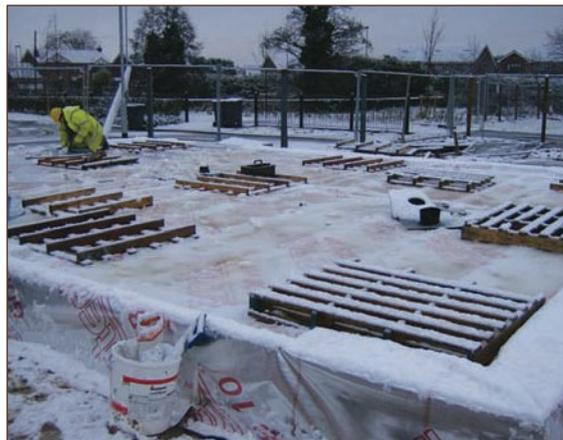
**Figure A4.84** Taped joints are difficult to construct in adverse weather. Also difficult to inspect if covered with snow (courtesy Smith Grant)

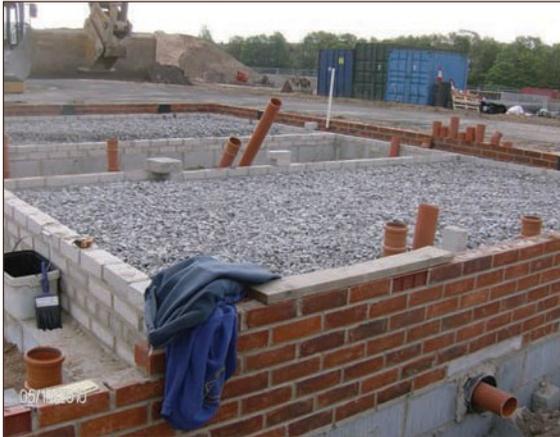
**Figure A4.85** Clean single sized stones with no fines acting as venting media, however no ventilation gaps in internal sleeper walls (courtesy Smith Grant)

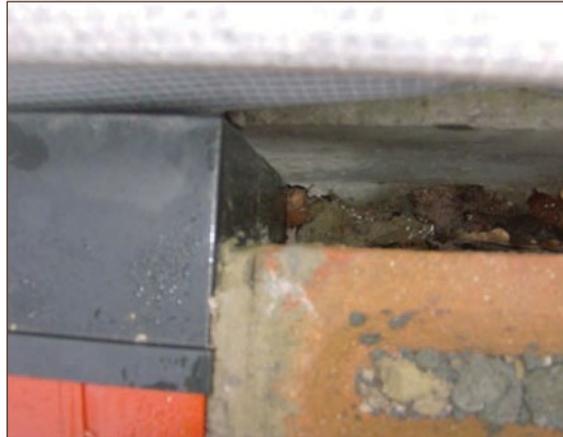
**Figure A4.86** Cavity is becoming blocked with detritus. The vent holes in the beam are no longer visible (courtesy Smith Grant)

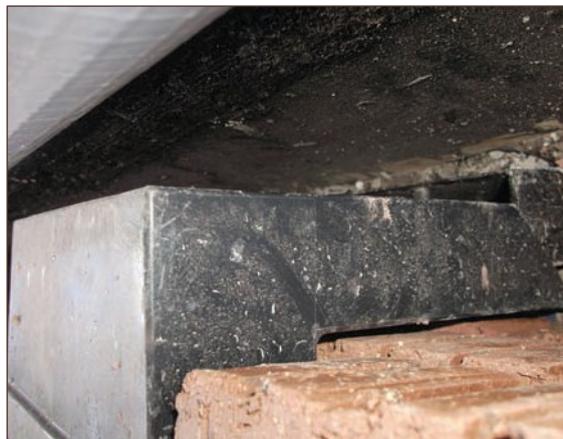
**Figure A4.88** Ventilator becoming detached to fit to external block work. This is due to builders requiring increased cavity widths to achieve thermal properties expected by Building Regulations (courtesy NHBC)

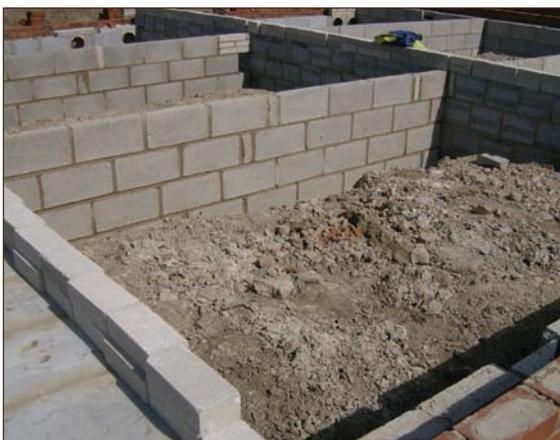
**Figure A4.89** No ventilation in internal sleeper wall (courtesy Smith Grant)
